**NO FURTHER ACTION
DECISION DOCUMENT
FOR STUDY AREA P51, ONE DRUM
NEAR WHITE POND ROAD,
SUDBURY TRAINING ANNEX**

FINAL DOCUMENT

**U.S. ARMY ENVIRONMENTAL CENTER
ABERDEEN PROVING GROUND, MARYLAND**

APRIL 1995

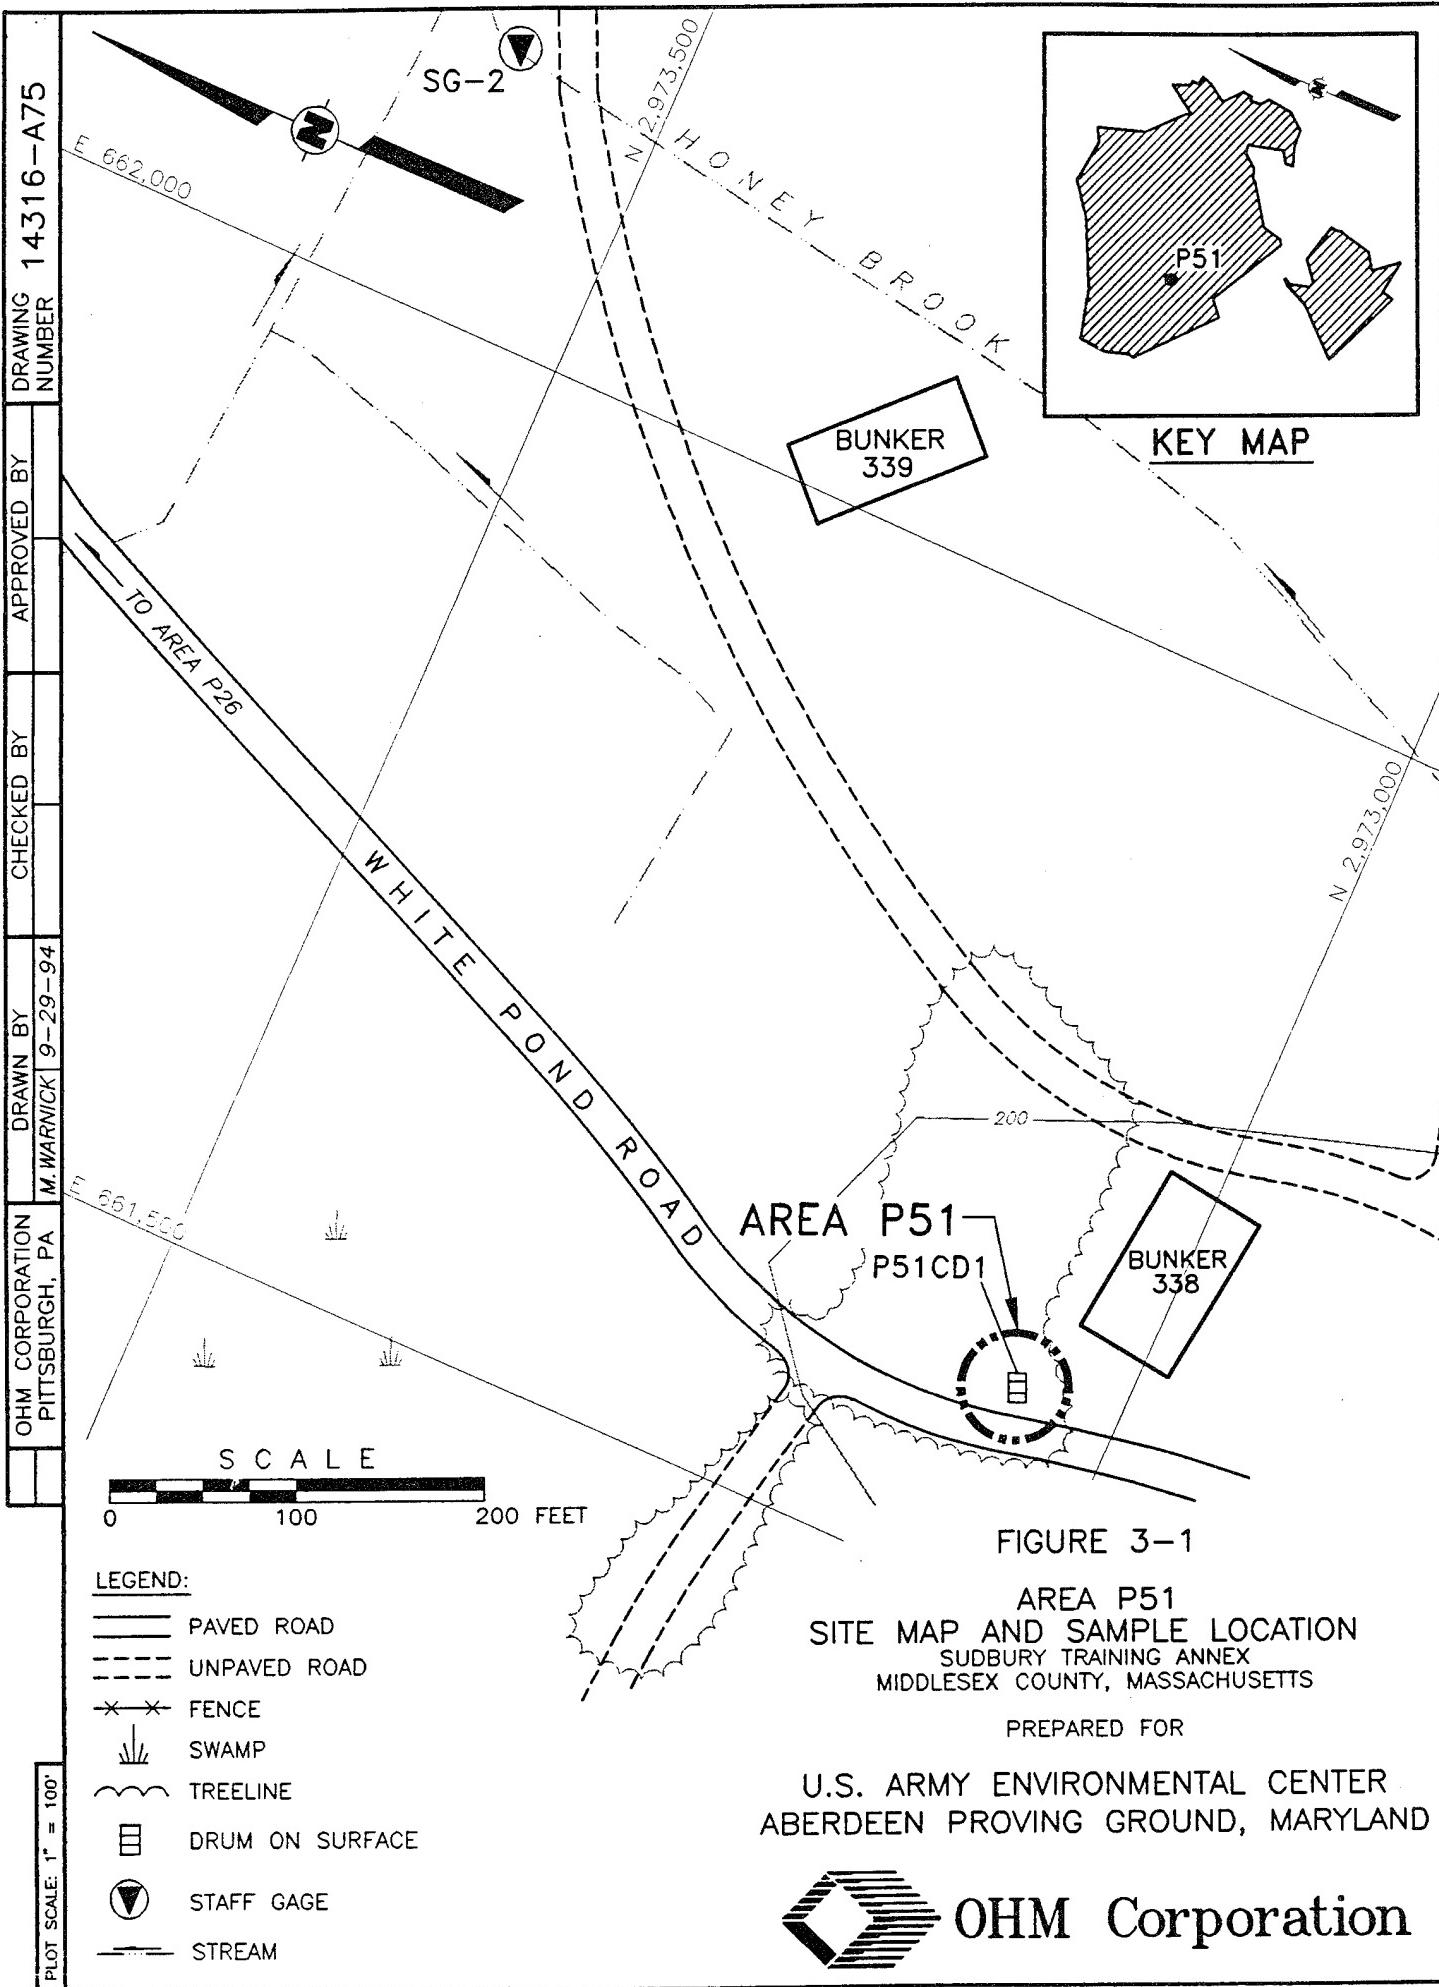
FIGURE 3-1
AREA P51
SITE MAP AND SAMPLE LOCATION
SUDSBURY TRAINING ANNEX
MIDDLESEX COUNTY, MASSACHUSETTS

Area P51 is located on White Pond Road, 1,200 feet northeast of Area P5. The access road to Bunker 328 is situated just south of the area. Figure 3-1 presents a map of the area. The surficial geology of this area has been classified as outwash plain (Hansen, 1956).

A site investigation of Area P51 was performed by OHM in 1991 and 1992. The drum located north of Bunker 338 were removed and staged at the temporary storage area assembled at the former MFFA. Scans of the soil with a PID and radiological survey meter did not reveal readings above background levels. Confirmatory soil sample P51CD1 was collected from the former drum location and analyzed for TCL volatile and semivolatile organic compounds, TCL pesticides/PCBs, TAL metals, and explosives. A summary of the positive detections for sample P51CD1 is presented in Table 4-1. Nine metals were detected in the soil sample. Copper, lead, mercury and potassium were detected at 14.4 µg/g, 77 µg/g, 0.367 µg/g and 751 µg/g, respectively, above the concentration limits determined from off-site background samples. One unknown VOC was detected at a low concentration. DDT, DDE, DDD and dieldrin were detected above background concentration at 0.283 µg/g, 0.512 µg/g, 0.18 µg/g, and 0.117 µg/g respectively.

Additional samples P51S01 through P51S04 were collected from a four-point grid established around the drum confirmation sample and analyzed for TCL pesticides/PCBs and TAL metals during the Phase II investigation. The sampling locations are presented in Figure 4-1. A summary of positive detections is presented in Table 4-2. The pesticides DDT, DDE, DDD, and alpha-Chlordane were positively detected in all samples. Showing no evidence of widespread contamination, the DDT, DDE and DDD detections were consistent with the prior drum confirmatory sample taken. DDT values ranged from 0.107 to 0.418 µg/g; DDE from 0.139 to 0.355 µg/g; and DDD from 0.039 to 0.152 µg/g. alpha-Chlordane, not detected in the prior sampling, was found in two of the four Phase II samples with a maximum detection of 0.044 µg/g. Several metals were also positively detected. Beryllium, copper, and lead were detected above their respective 95% UCL for background soil samples. Beryllium was detected in one of four samples at 0.234 µg/g. Copper with detections ranging from 9.25 to 26 µg/g exceeded its 95% UCL level of 10.56 µg/g in three of four samples. Lead with detections ranging from 45 to 70 µg/g in all four samples. Selenium was also detected at concentrations ranging from 0.49 to 1.1 µg/g but it does not have a background level.

Based on the preliminary risk evaluation of Study Area P51 (One Drum Near White Pond Road), it is concluded that no further investigation or remediation is required at this study area. Sampling following drum removal has shown pesticide and metals concentrations below and within human health and ecological screening values.
